**RE: Response to Comments for the Self-Implementing On-Site Cleanup and Disposal Plan, PCB-Containing Caulk, Window Glazing, and Soil
903 Farmington Avenue
Southington, Connecticut
Eagle Project No. 11-015.14A**

903 Farmington Avenue
Berlin, Connecticut

Town of Berlin
240 Kensington Road
Berlin, CT

March 28, 2012
Revised: May 7, 2012

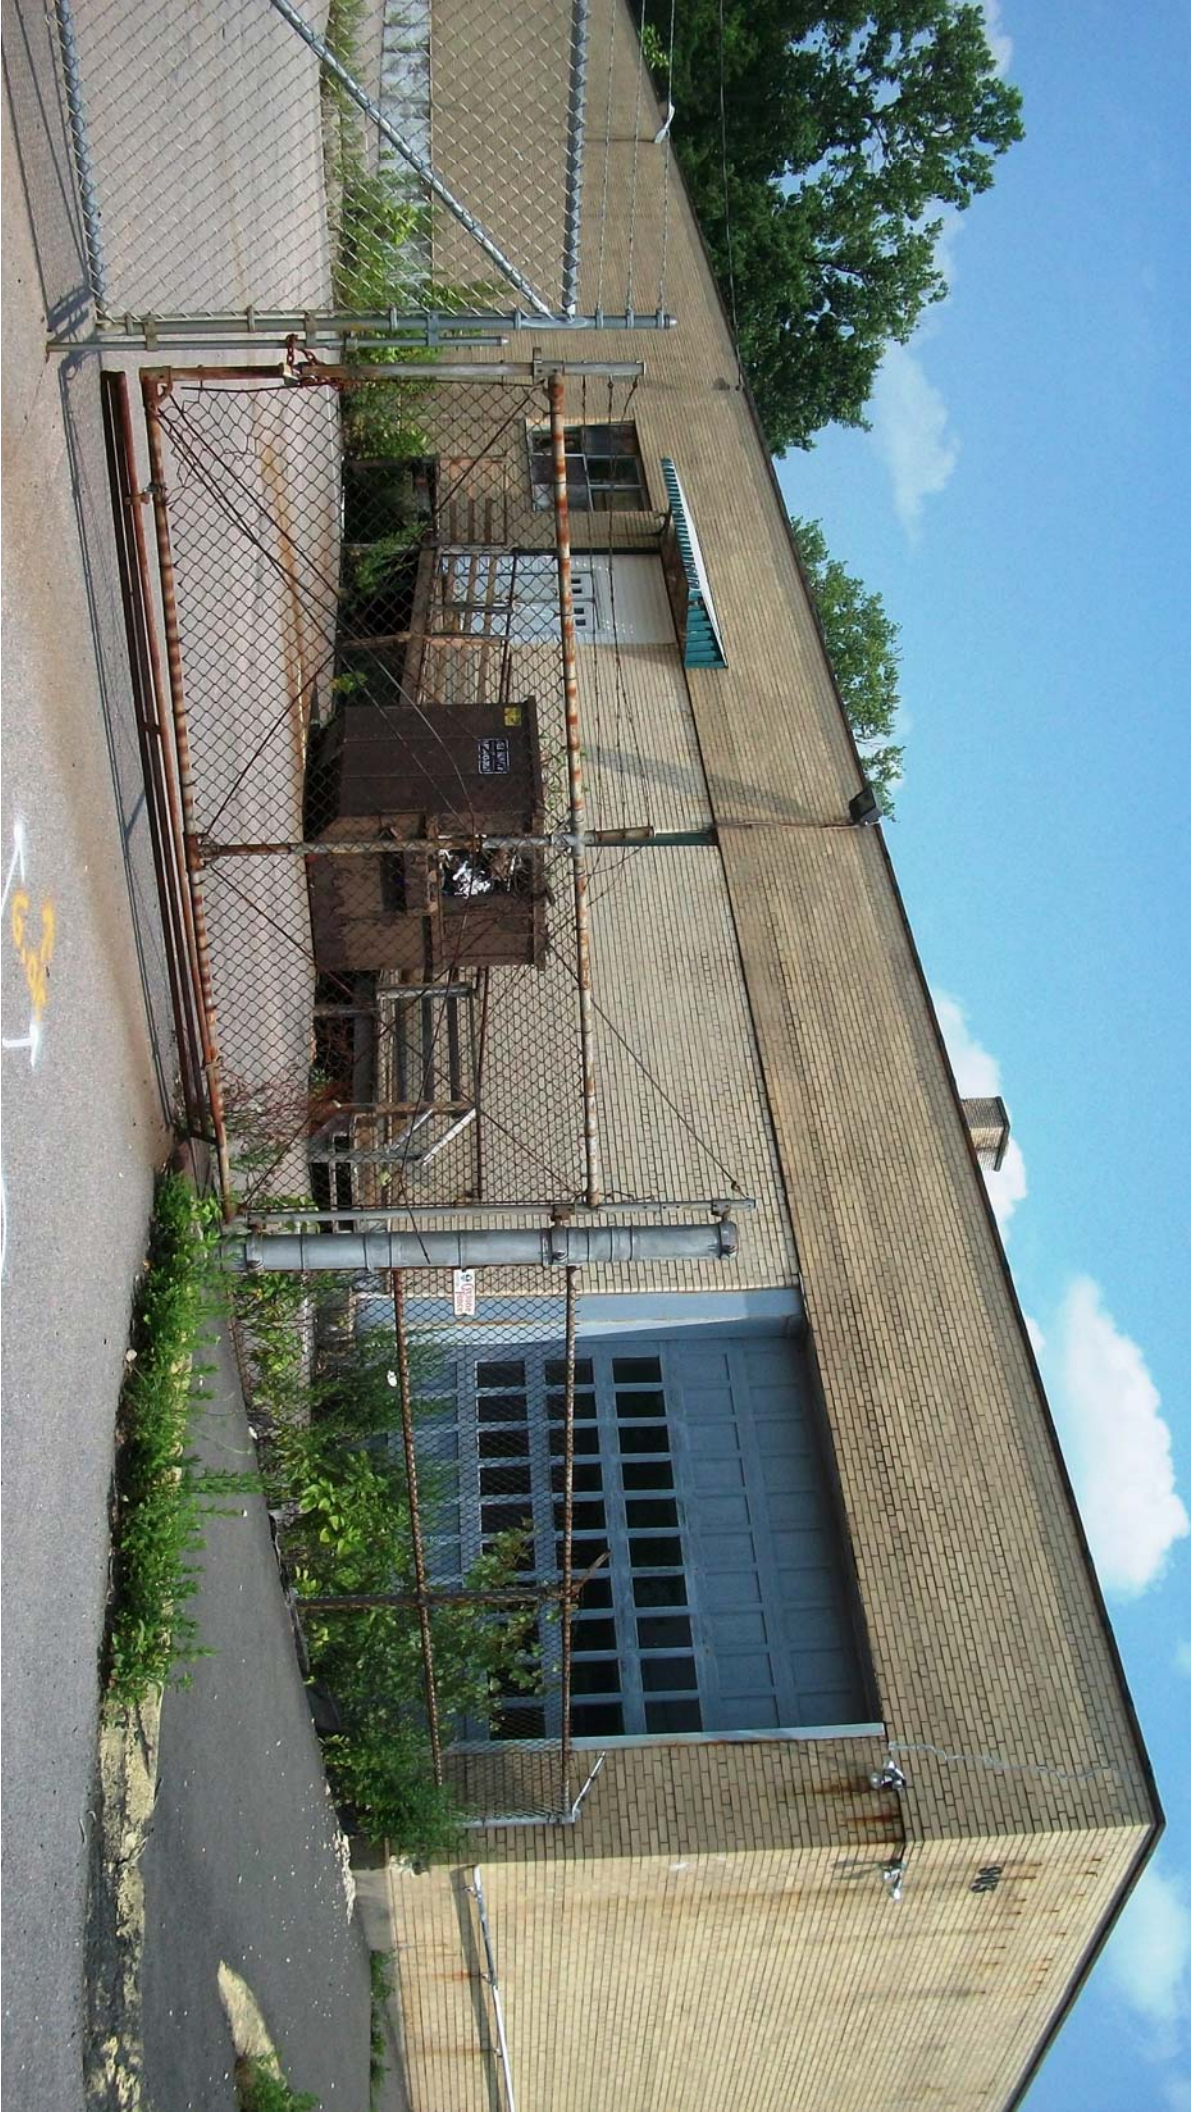
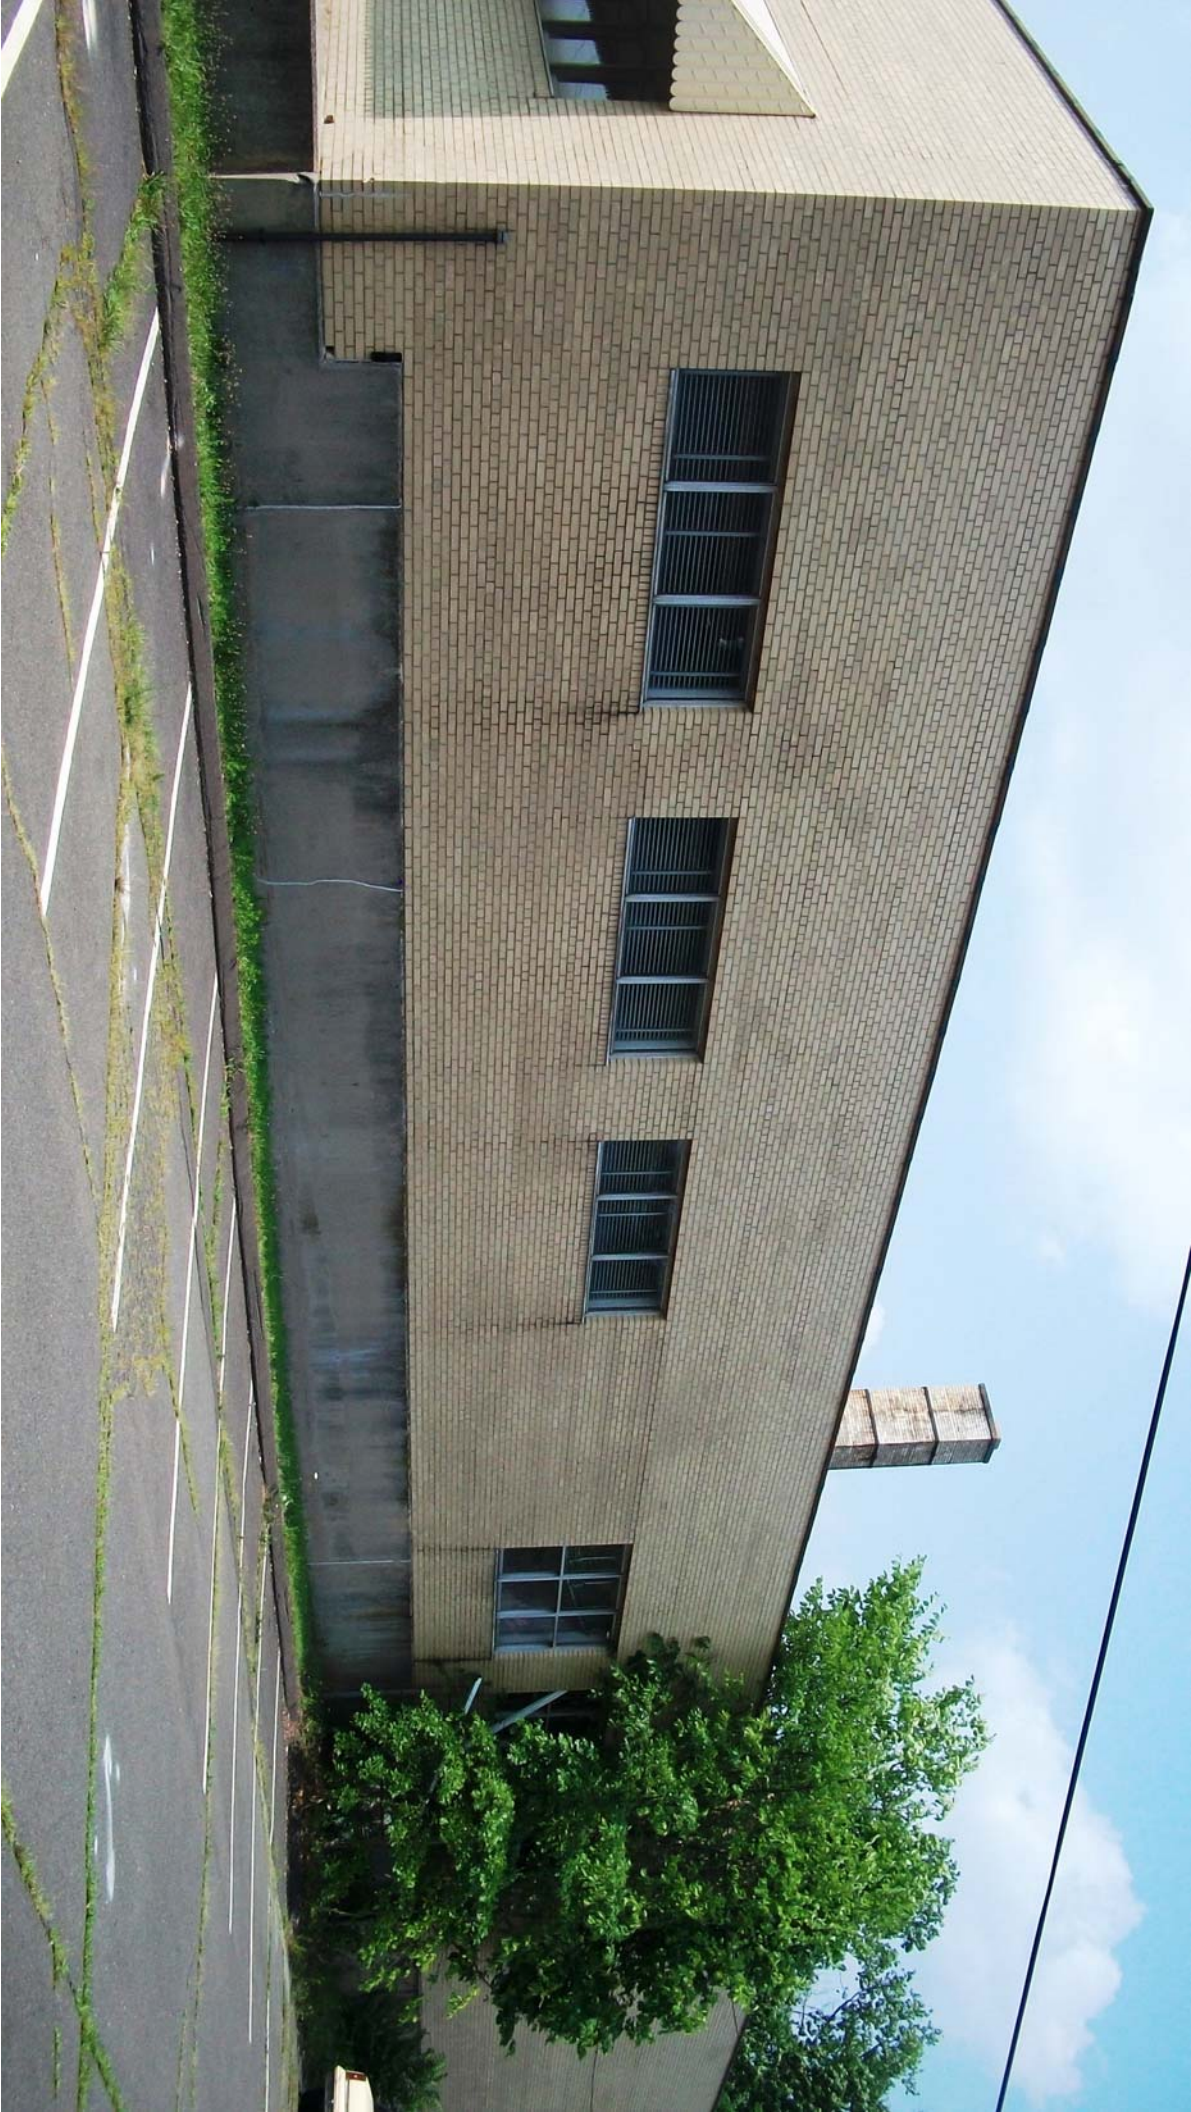
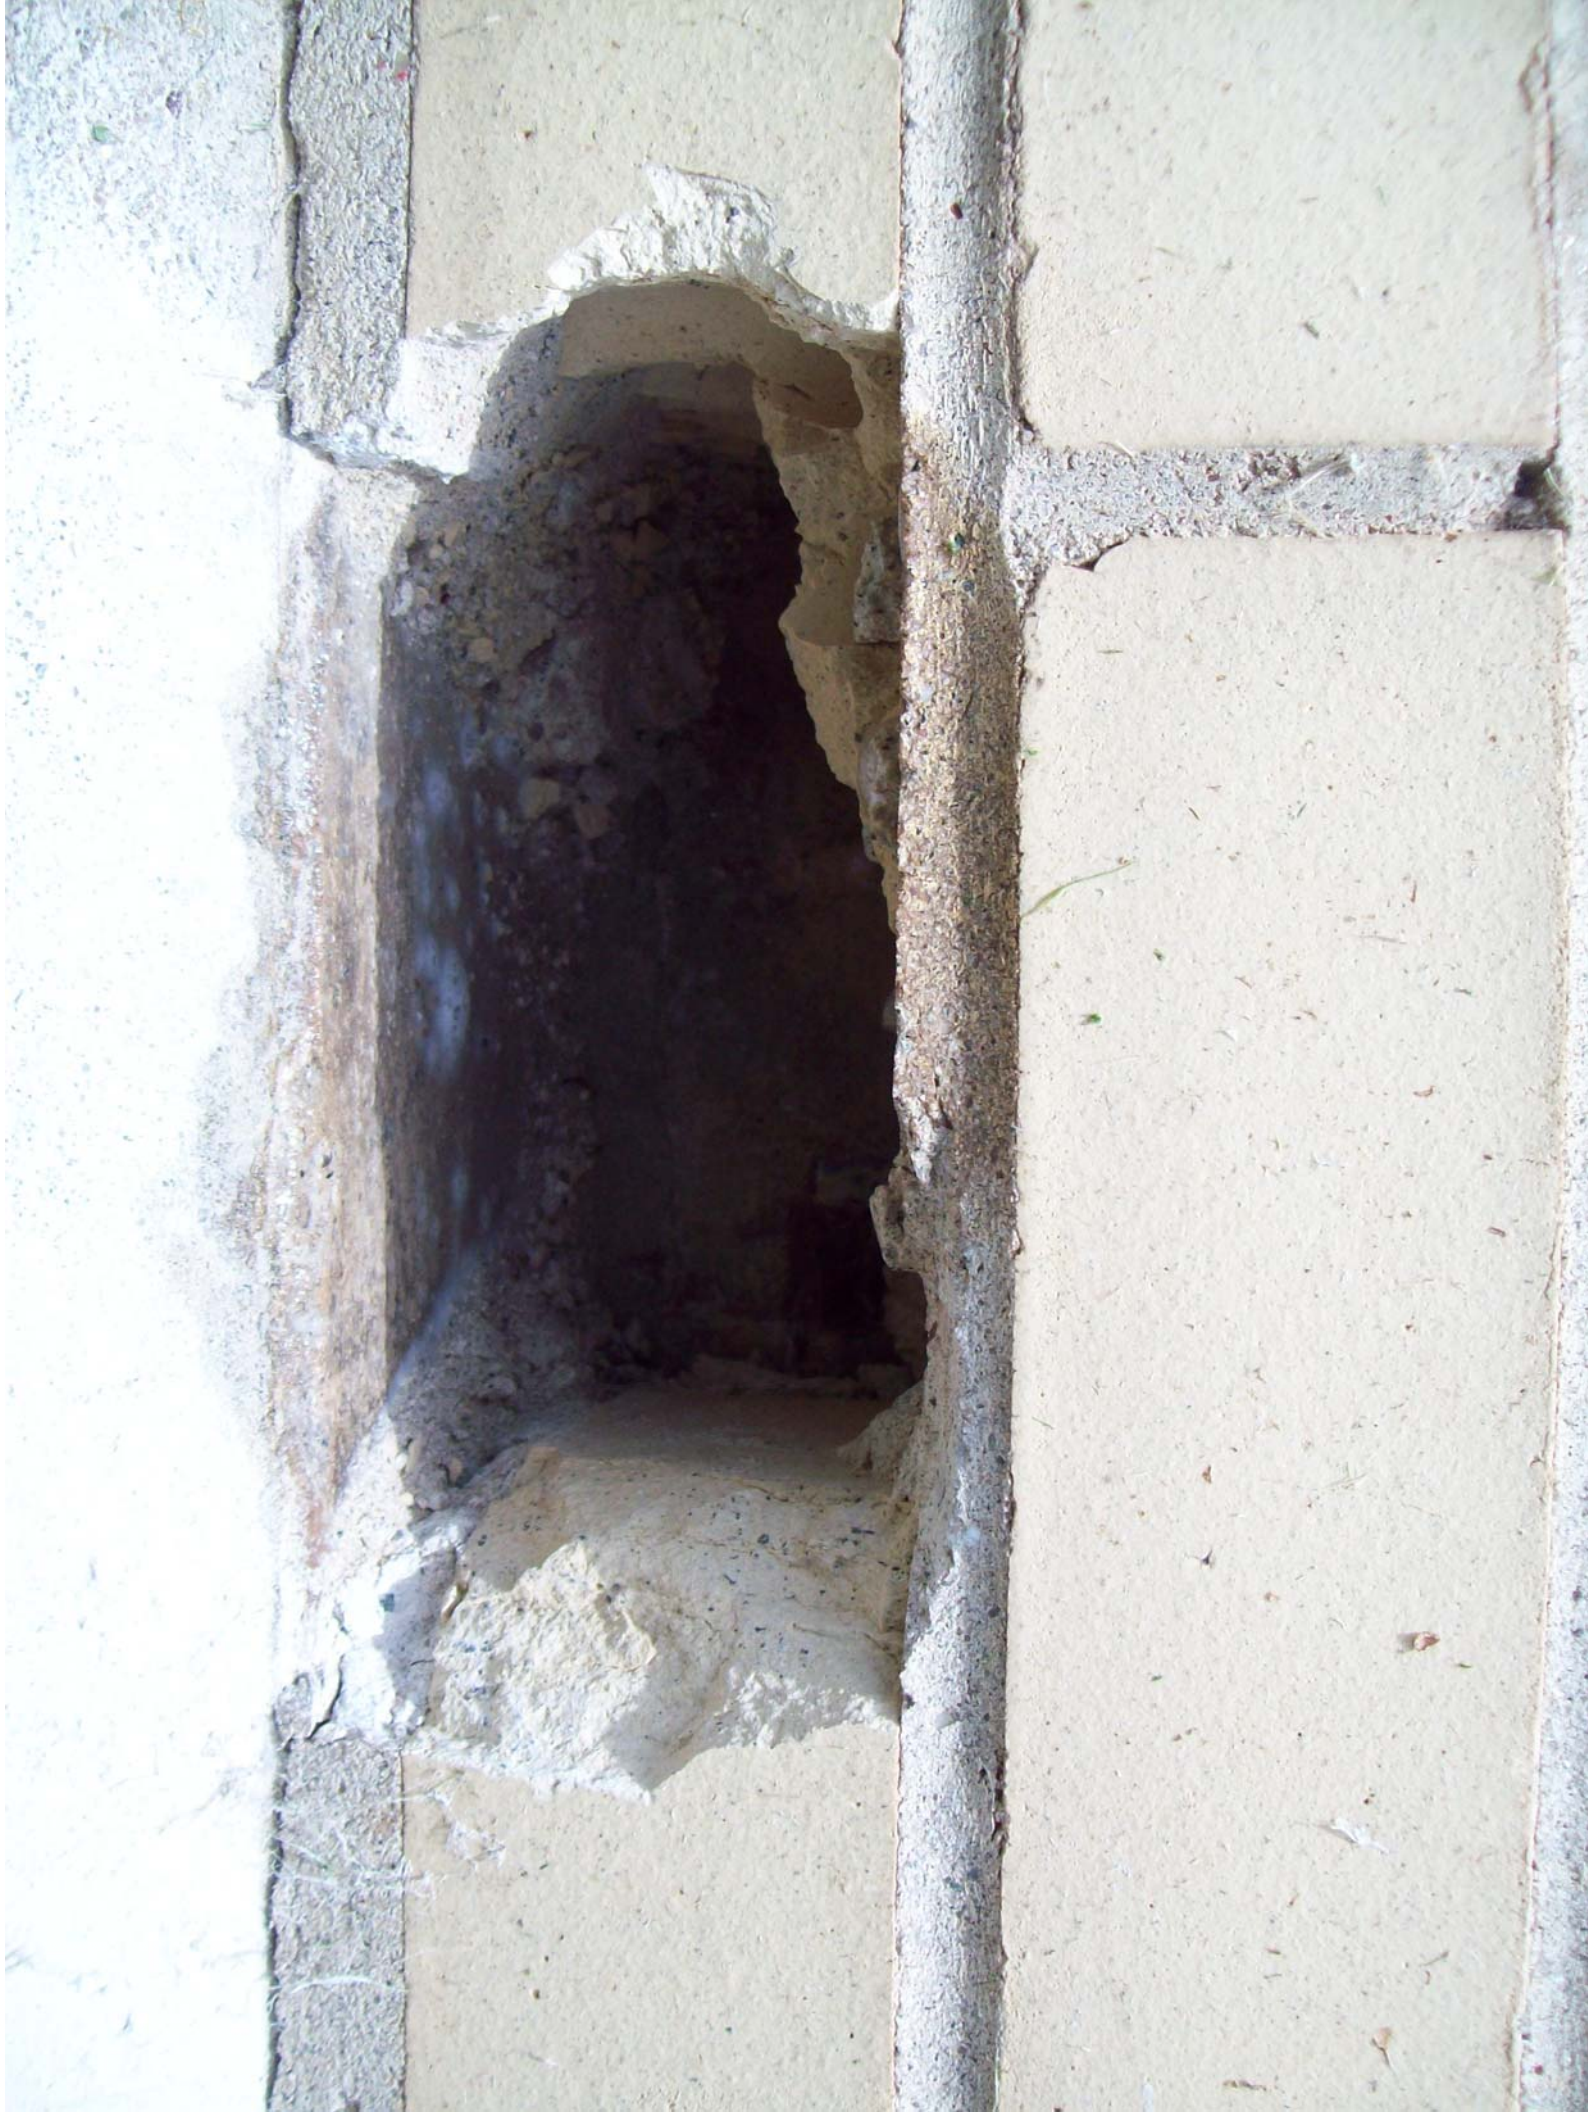
DIAGRAM 2-4

PHOTOGRAPHS OF CAULK/SUBSTRATE JOINTS

1. Please see the photographs attached as Diagram 2-5 of the revised Notification depicting configuration of caulk/substrate joints.
2. Page 9, Section 2.2.4
 - a. Yes, these items are present. Table in Section 2.2.4 of the Notification has been modified to include this. Also, the corresponding table in Section 3, page 2 of the Technical Specification has been modified.
 - b. Cleaning and remediation of the I-beams and lintels have been added in Section 3.6 D, page 15 of the Technical Specification.
3. Page 11, Section 3, Item 3.c
